, FRACTOGRAPHY OF RIM POLYCARBAMATE

MATERIALS,

Thesis

The School of Engineering of the
UNIVERSITY OF DAYTON

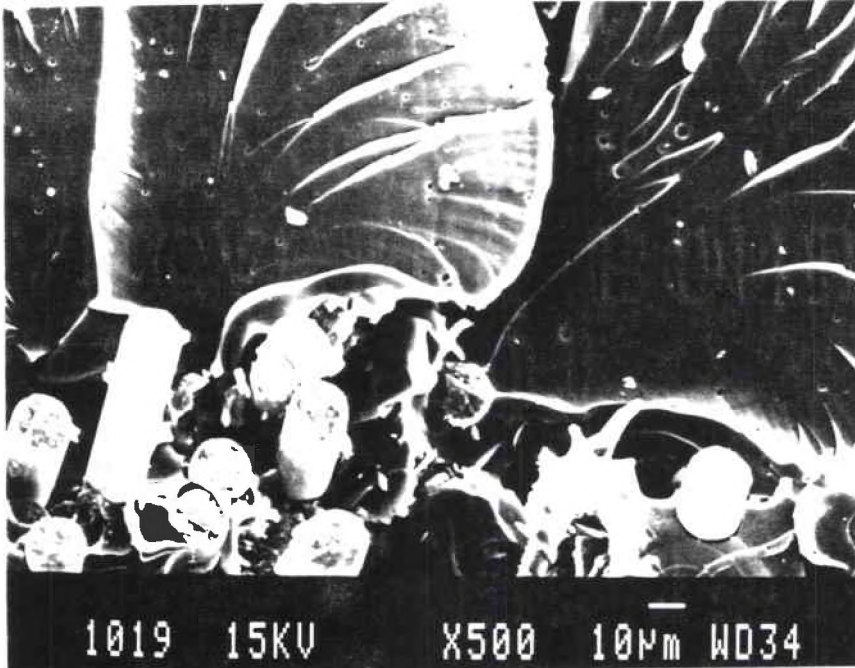
Figure 49. Tensile side of a thermally-aged flexure specimen (x500).

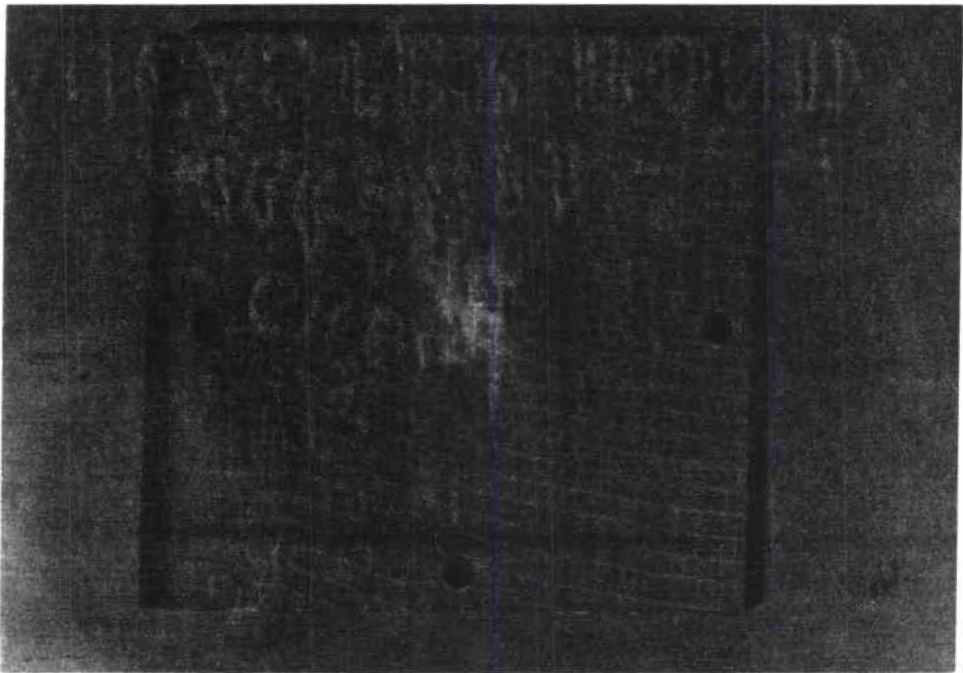
Figure 84. Impact specimen, (Back, RT).
